Ceramic Applications in Turbine Engines

Harold E. Helms, Peter W. Heitman,
Leonard C. Lindgren, and Samuel R. Thrasher
Allison Gas Turbine Division
General Motors Corporation

October 1984

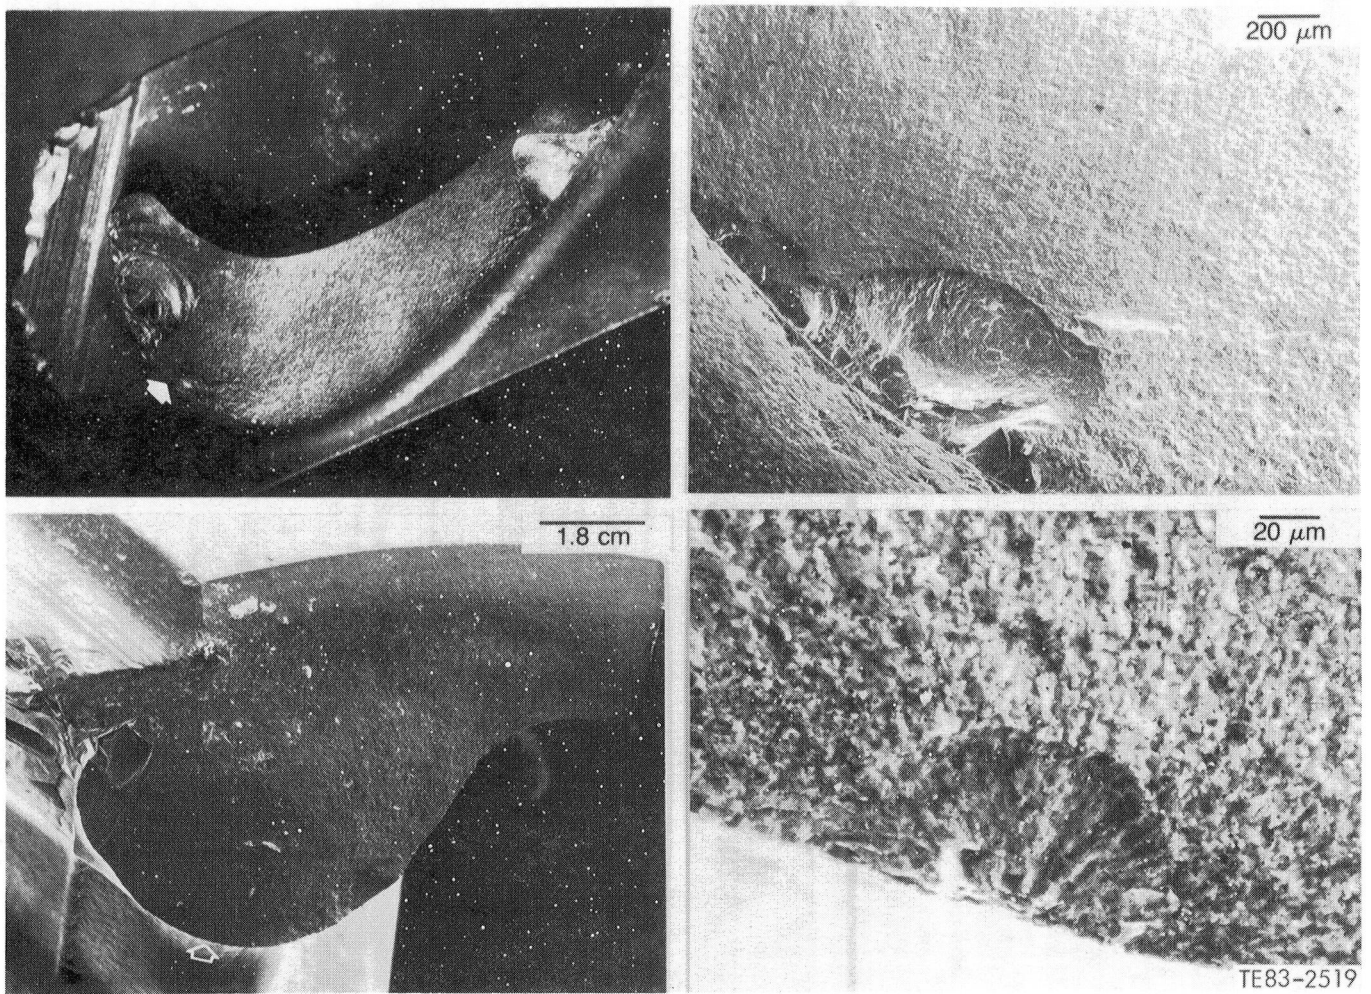
Figure 49. Example of blade primary fracture shearing through airfoil (note penny-shaped crack at secondary origin.)

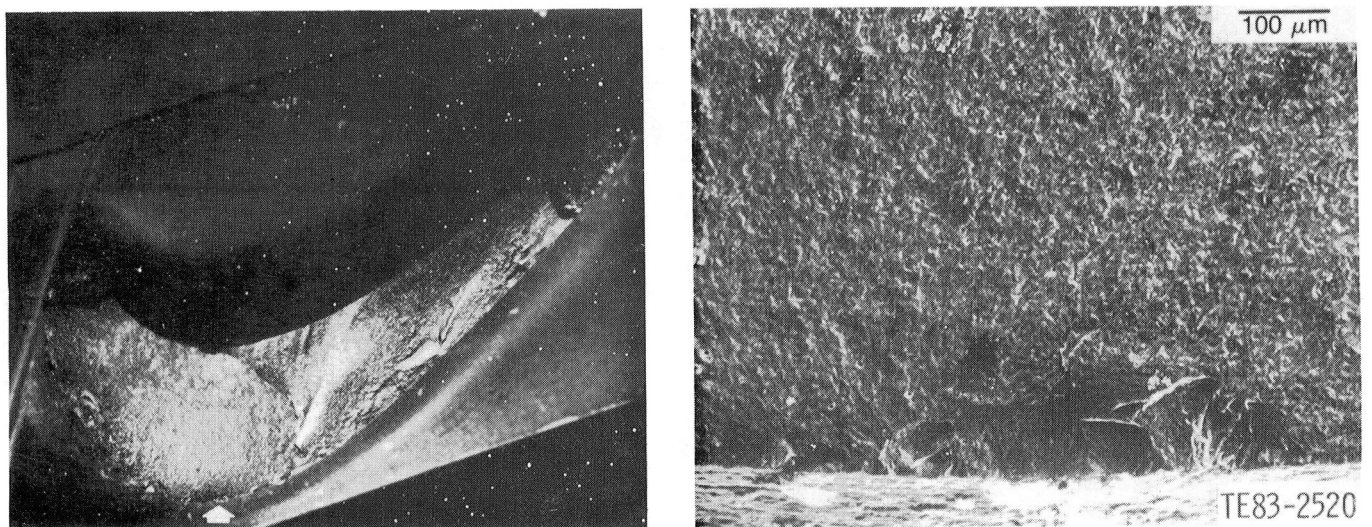
Figure 50. Blade fracture propagating along suction side of airfoil.

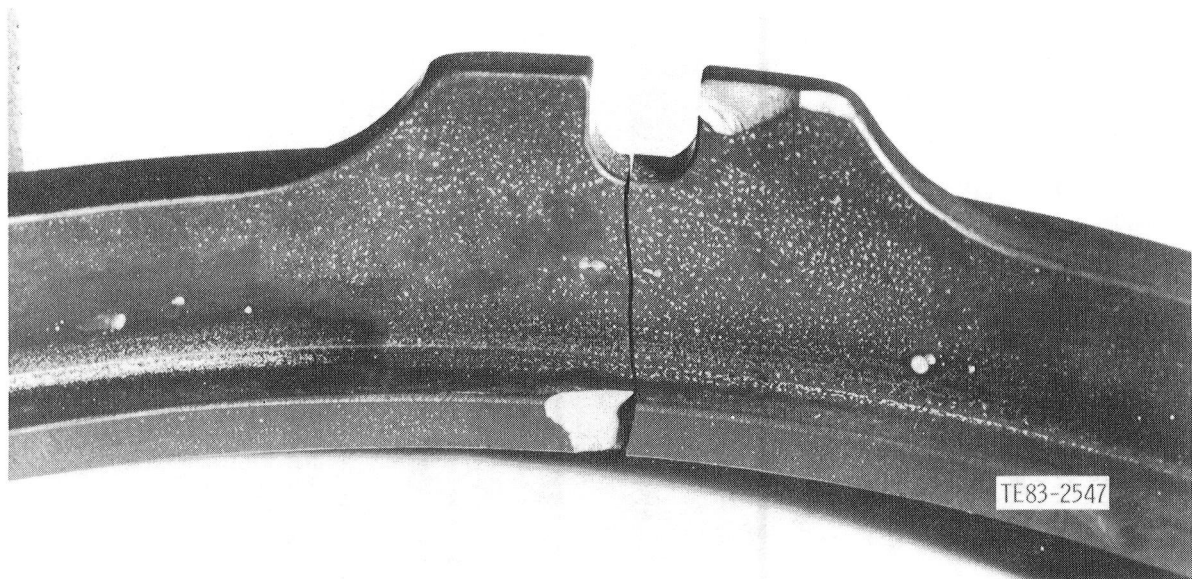
Figure 77. Cracked inner vane support ring for engine C-4, TD14.

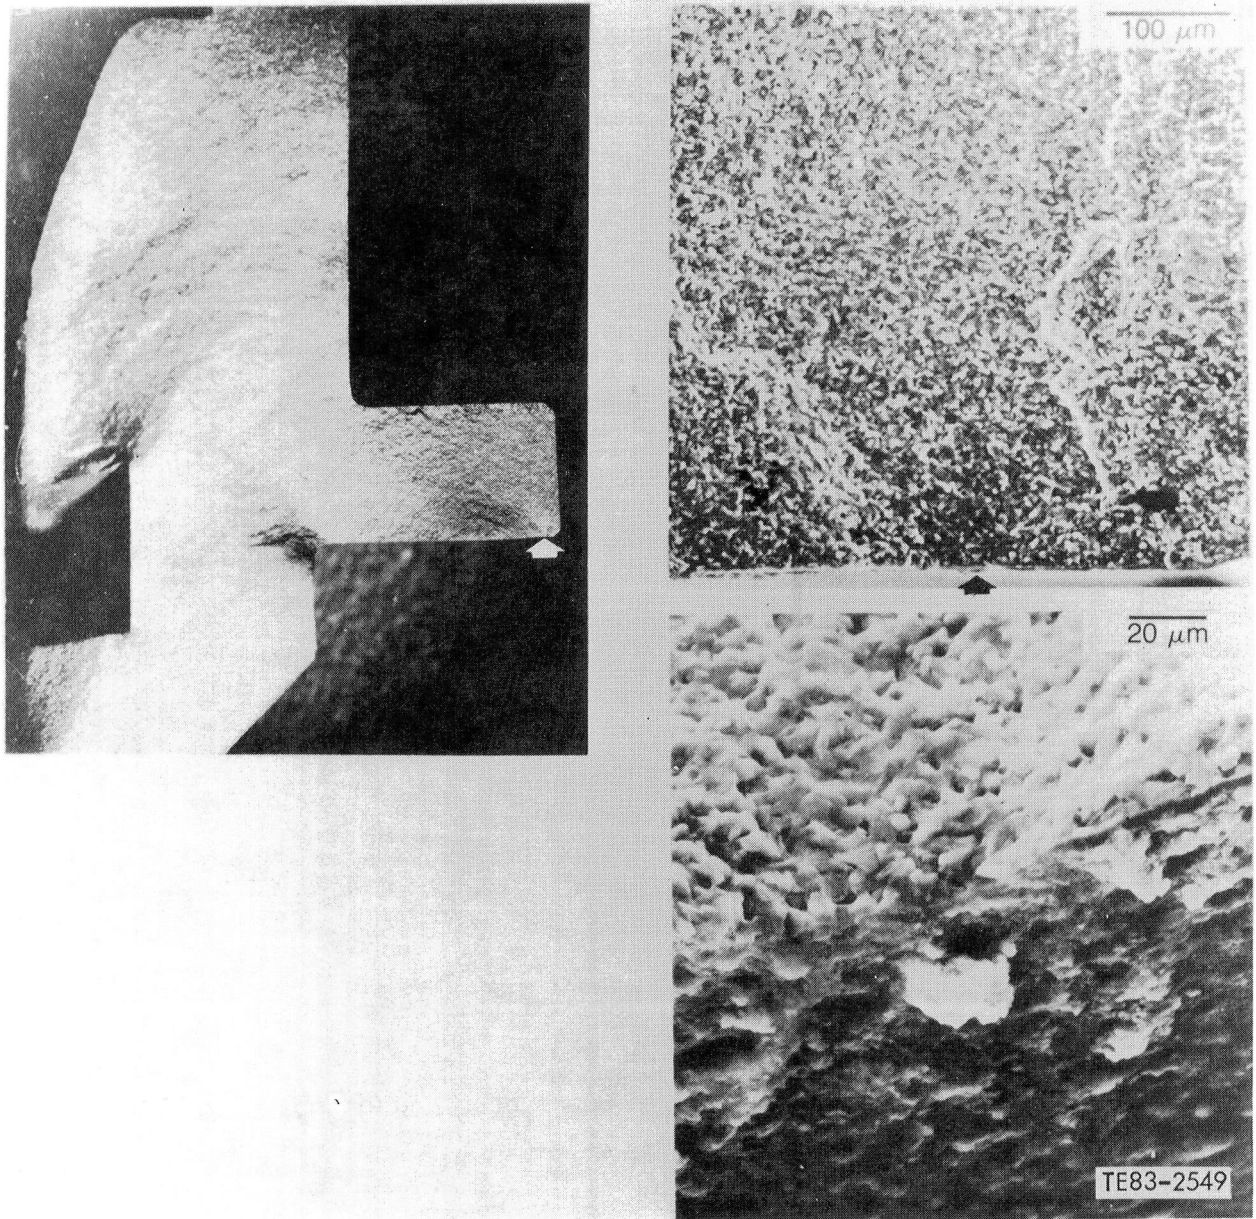
Figure 79. Fracture surface, inner vane support ring for engine C-4, TD14.

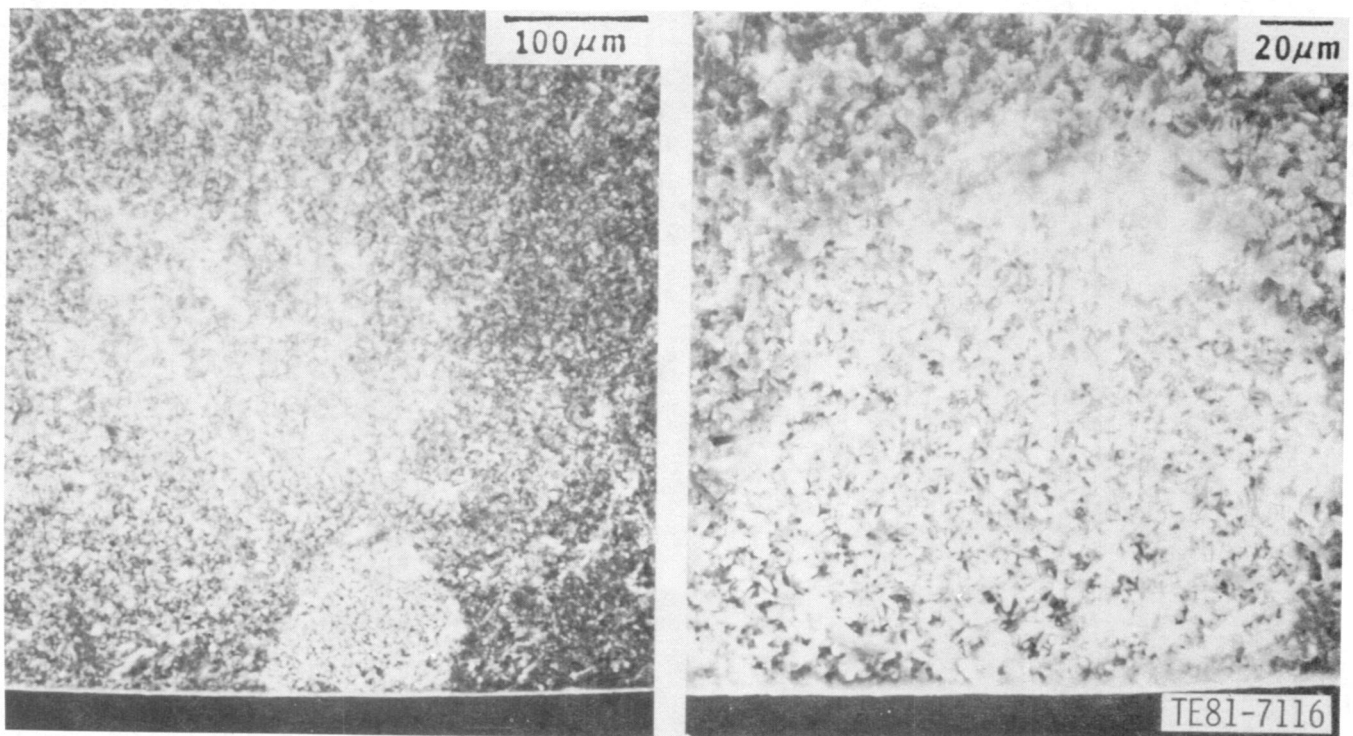
Figure 134. Fracture surface of NGK-Locke Si_3N_4 inner vane support ring test bar, showing large, low-density pocket.

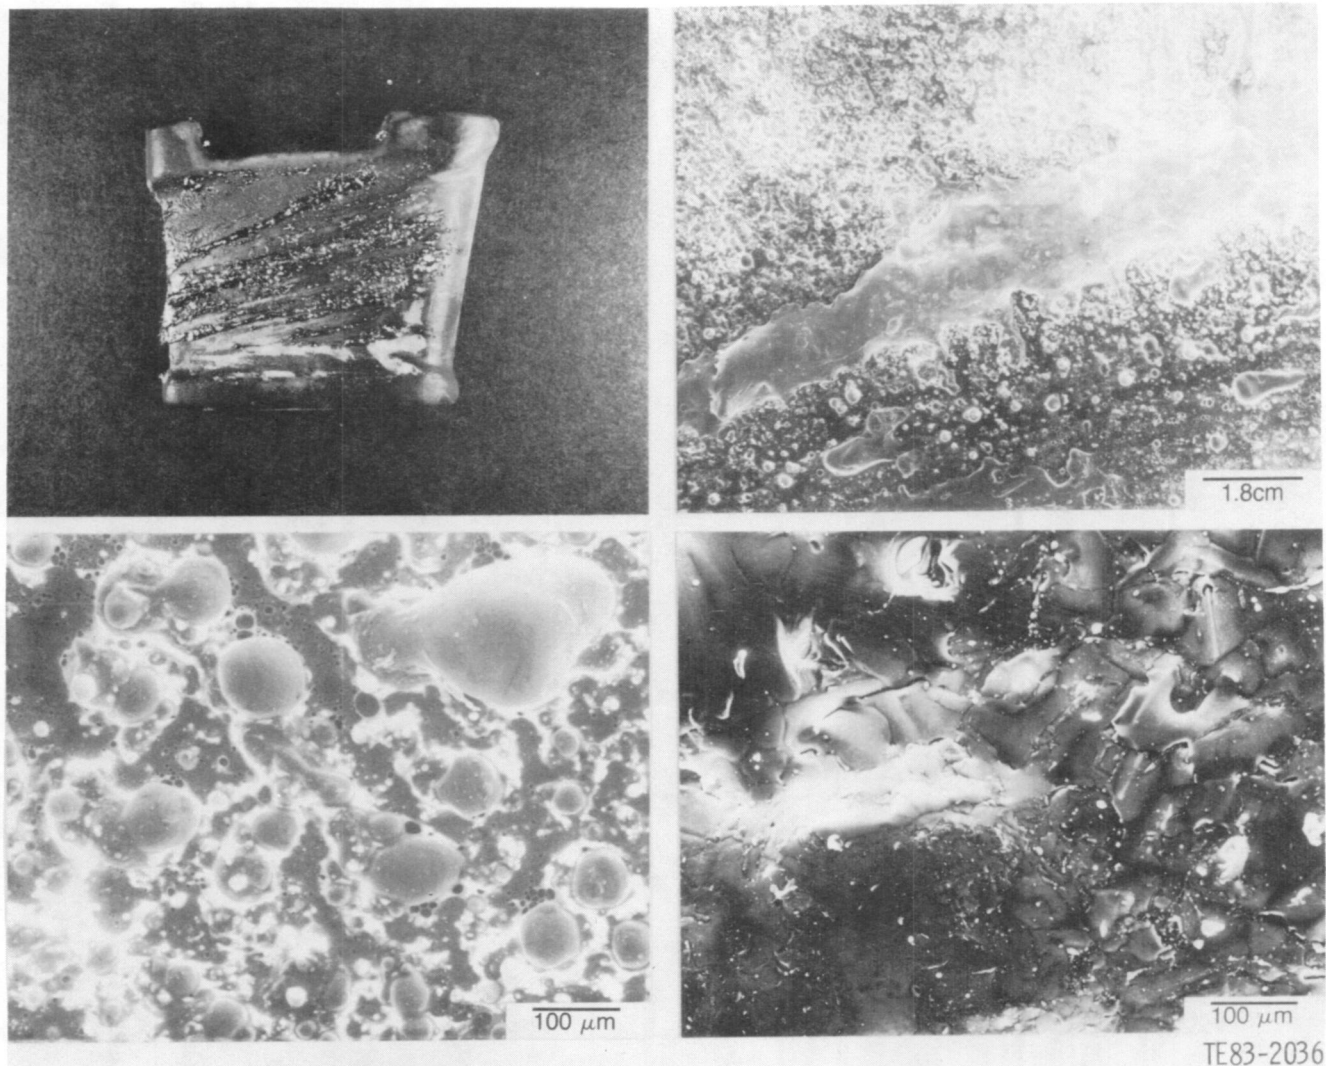
Figure 278. RBSiC vane (S/N FX 23775) with silicon exuded.

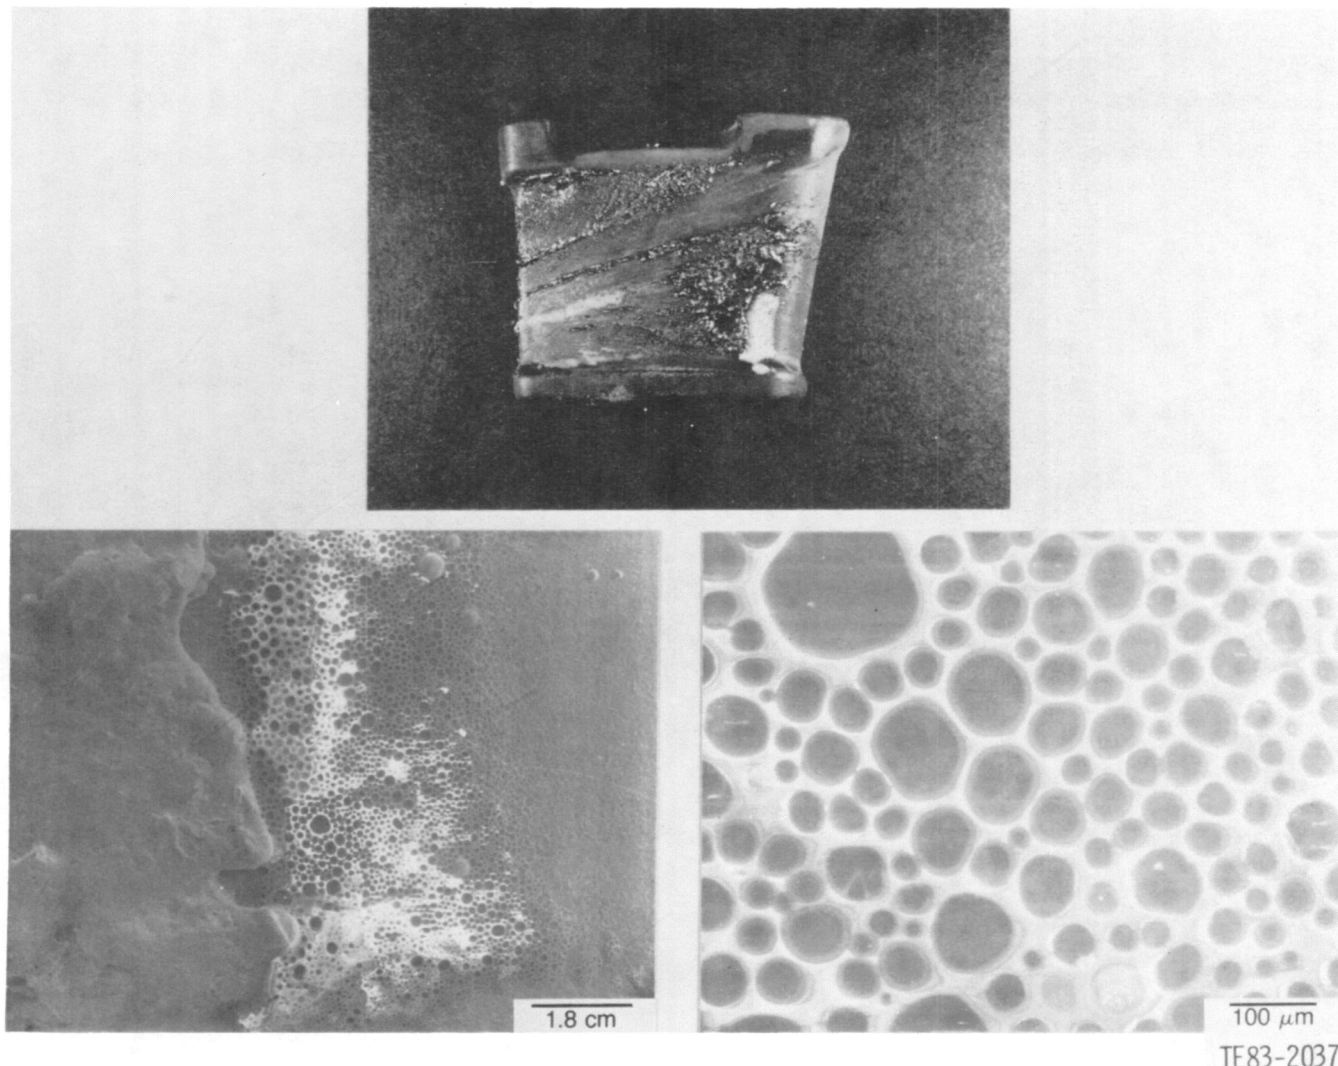
Figure 279. RBSiC vane (S/N FX 23776) with silicon exuded.

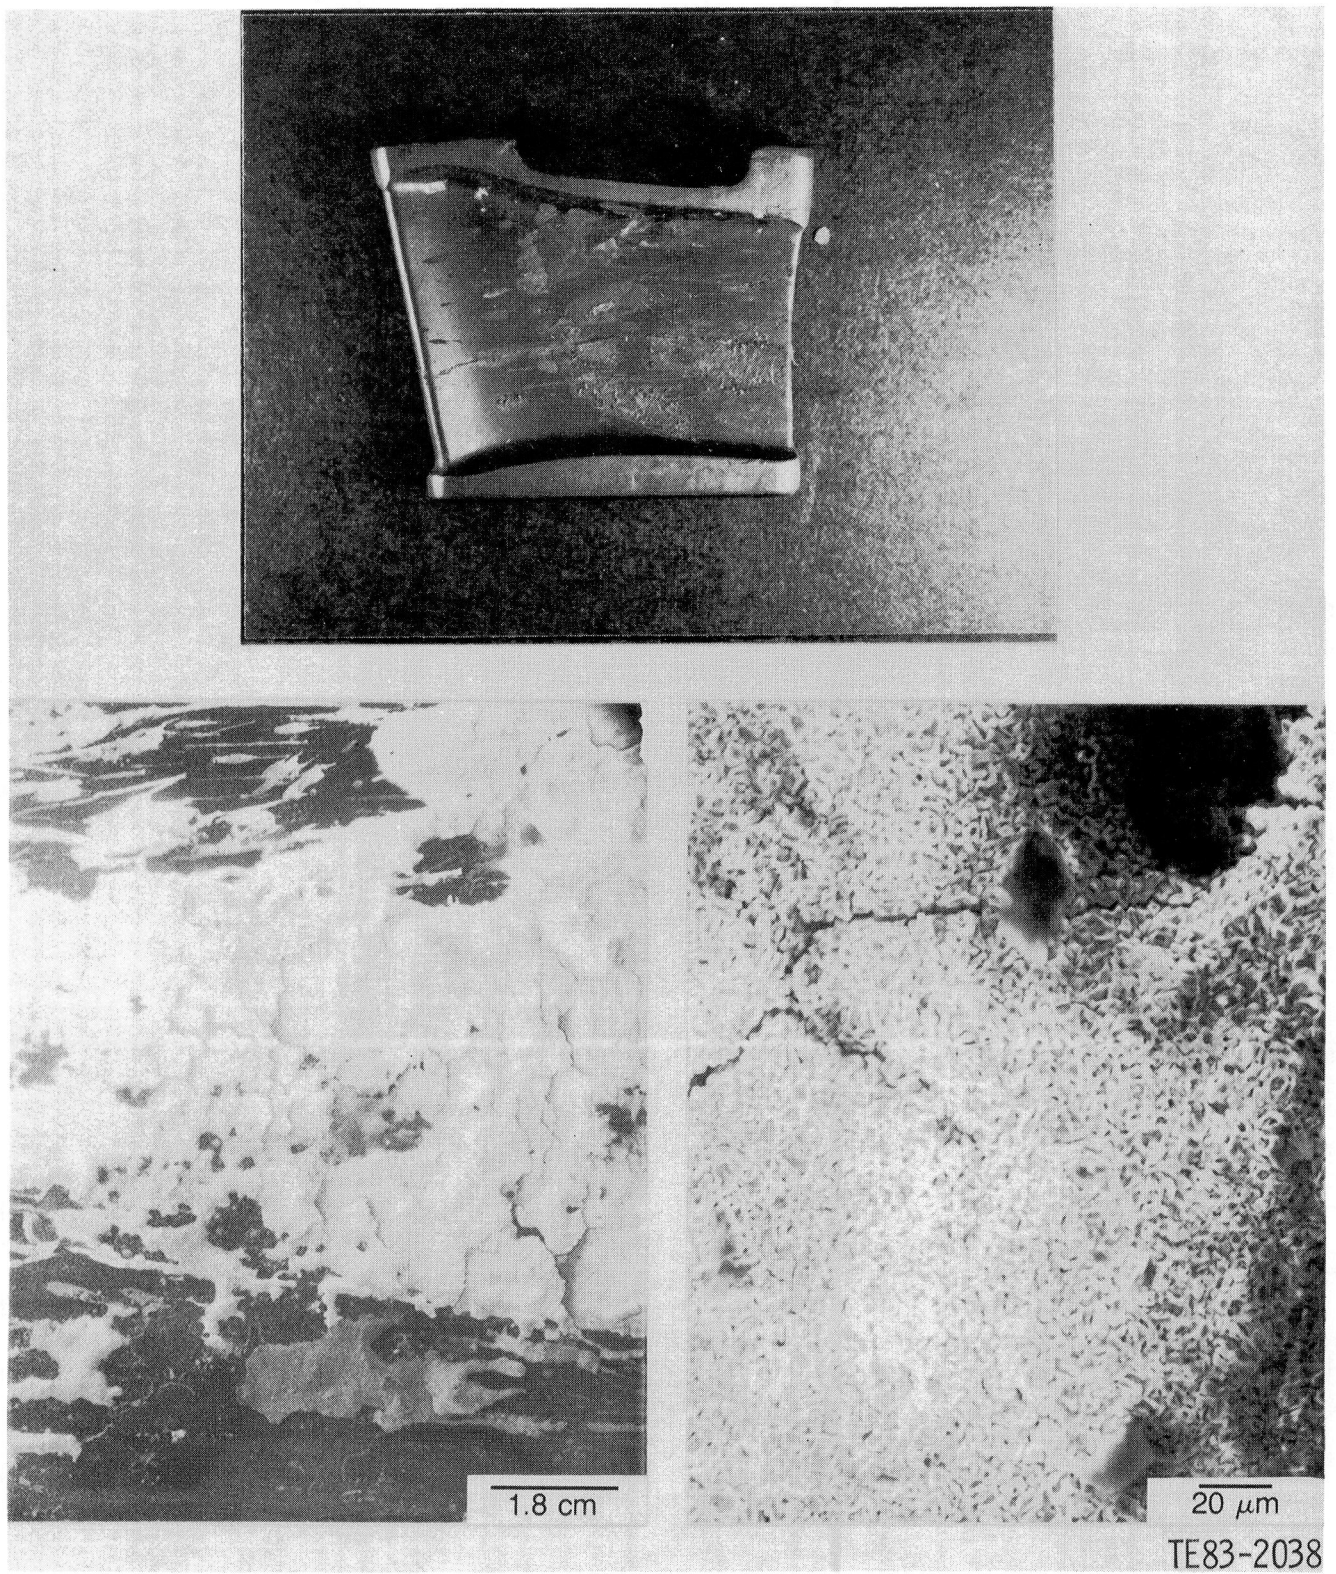
Figure 280. Metal deposits on vane S/N FX 23961 after testing in thermal shock rig, BU10.

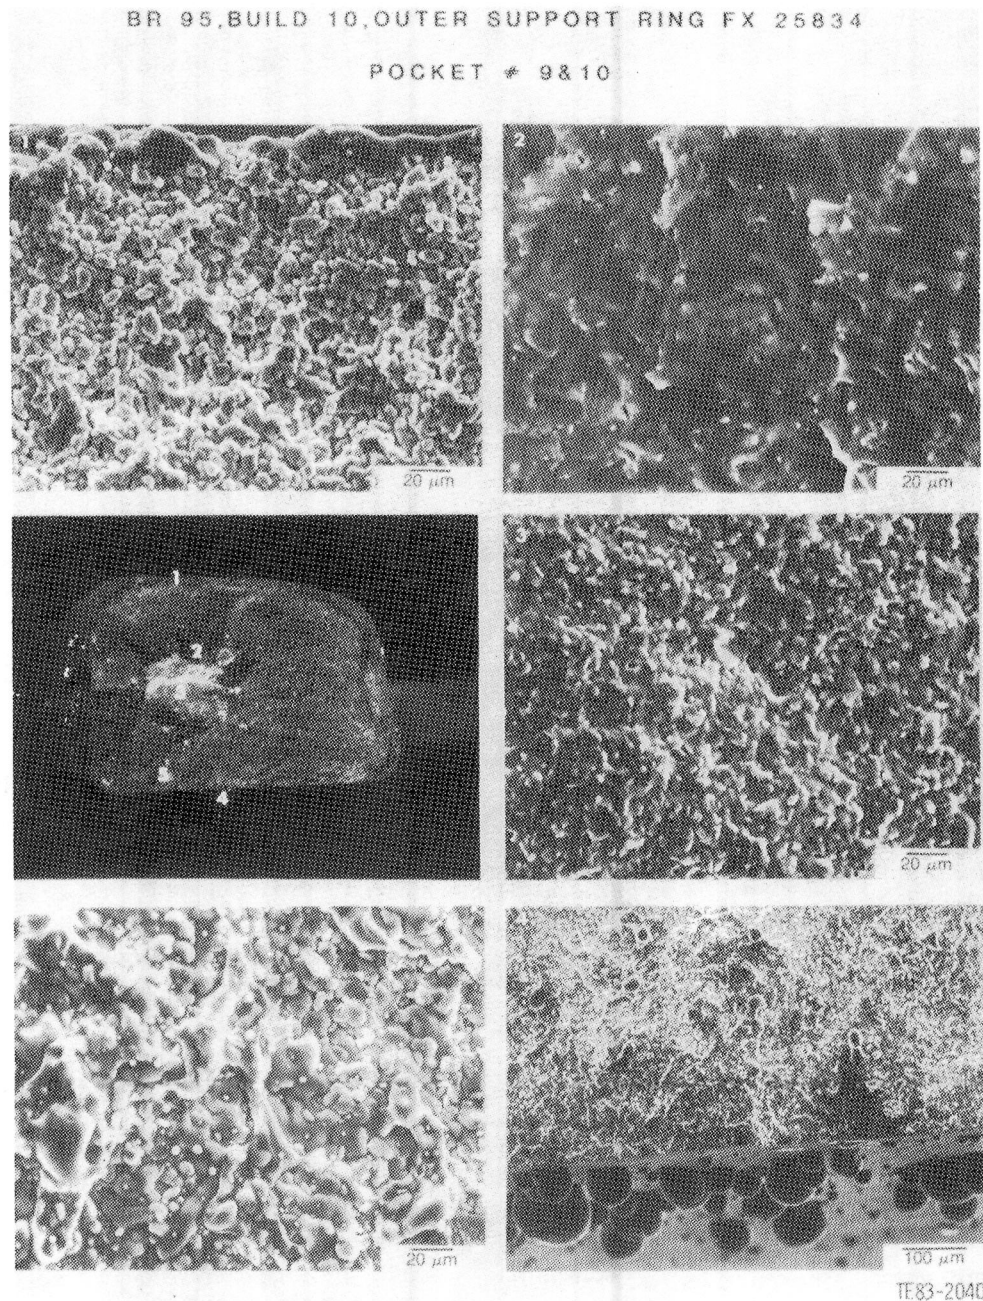
Figure 282. Cross section of outer vane support ring slot broken in BU10 of thermal shock rig.

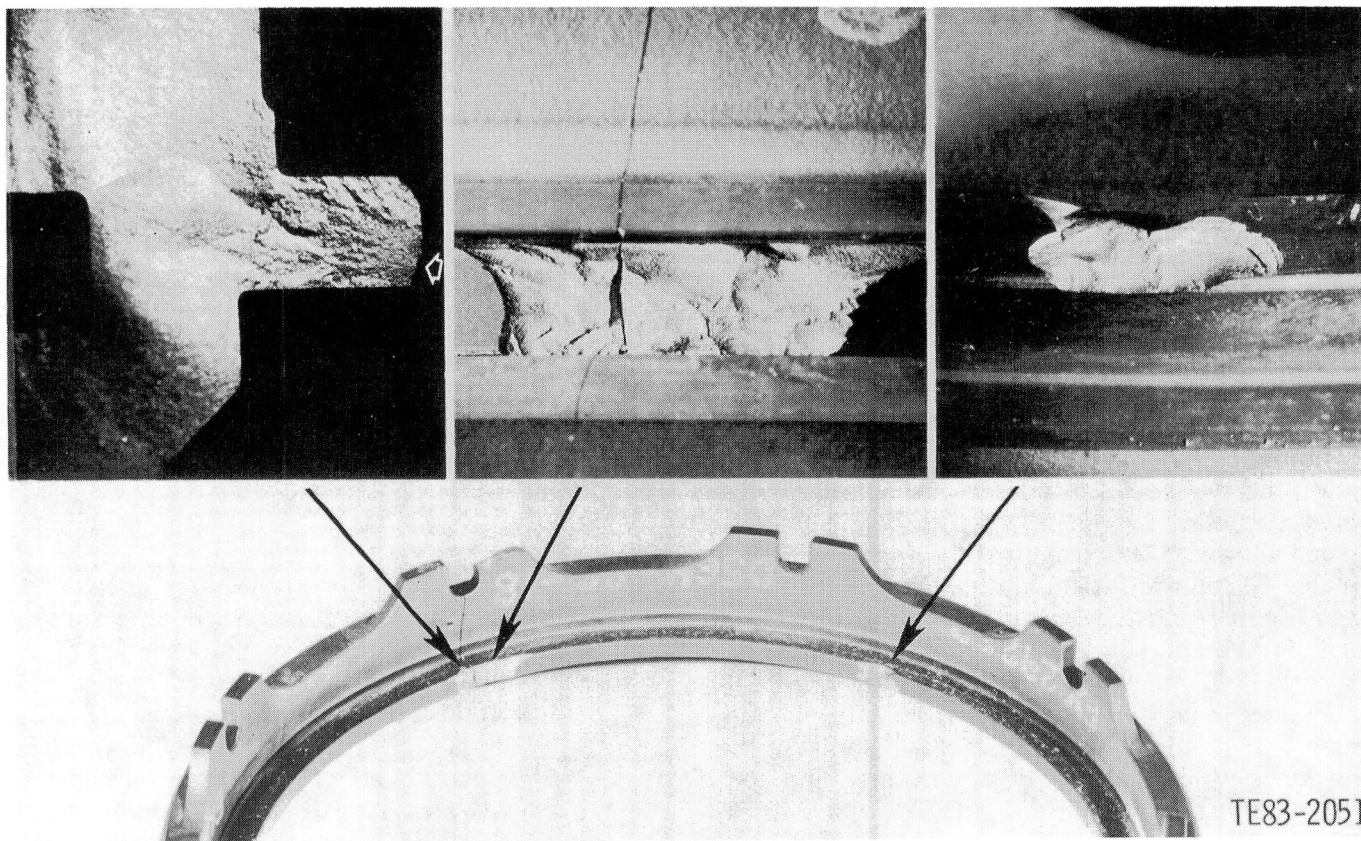
Figure 287. Failure origin of RBSiC inner vane support ring (S/N FX 29257).

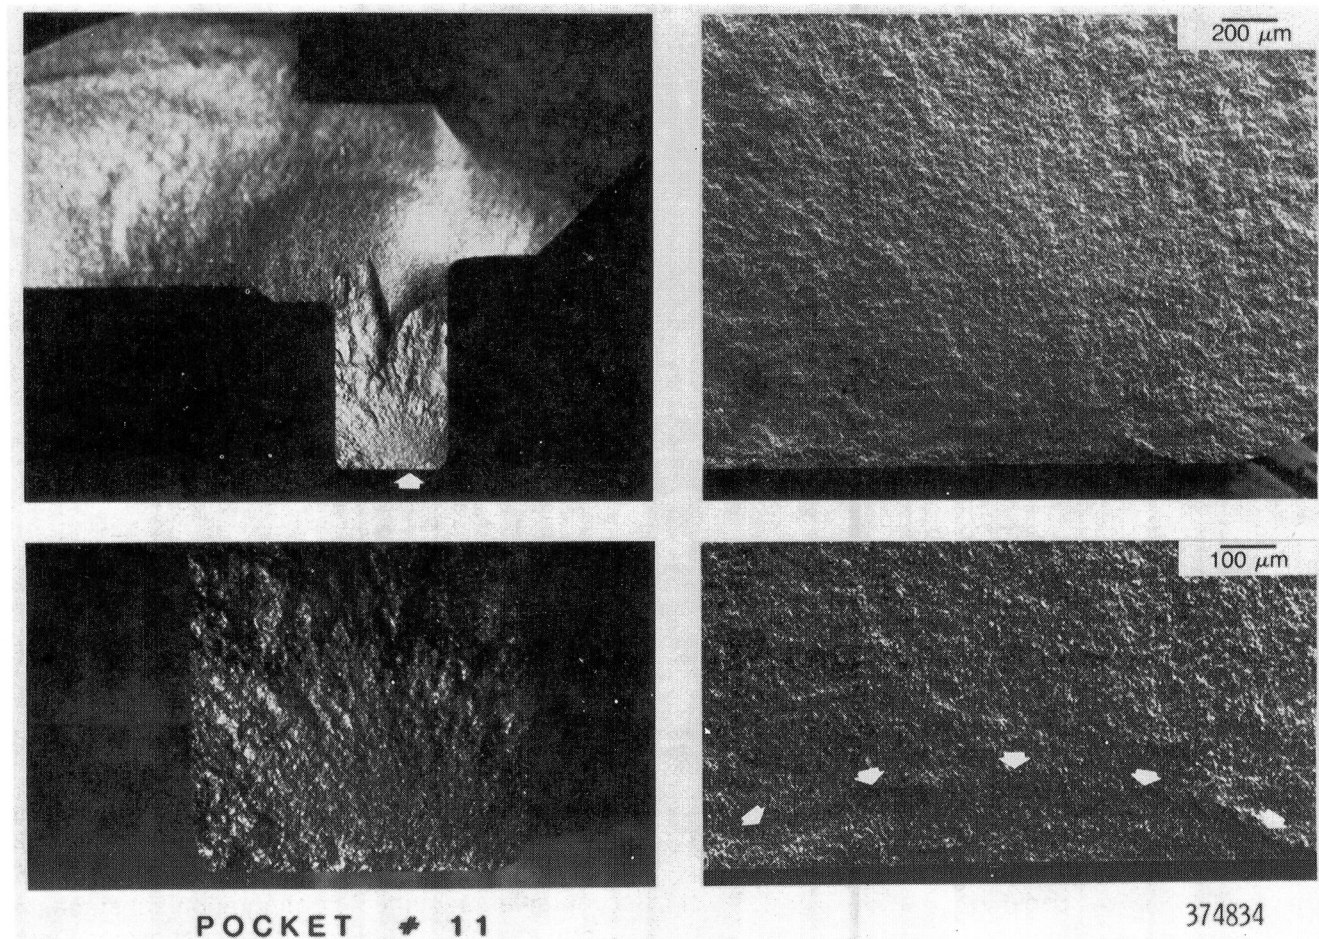
Figure 293. Failure origin of RBSiC inner vane support ring (S/N FX 29258).

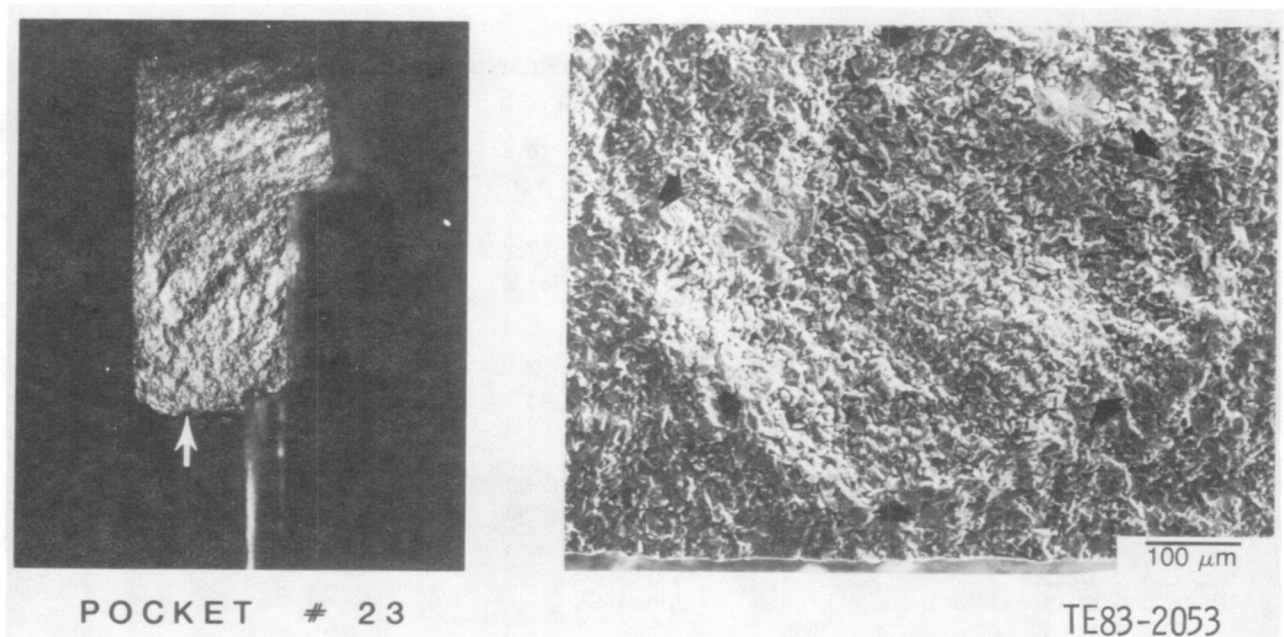
Figure 295. Failure origin of Pure Carbon Refel SiC outer vane support ring showing large pore.
